Hubble Space Telescope Fine Guidance Sensor Post-Flight Bearing Inspection

J. Pellicciotti*, S. Loewenthal**, W. Jones Jr.+ and M. Jumper**

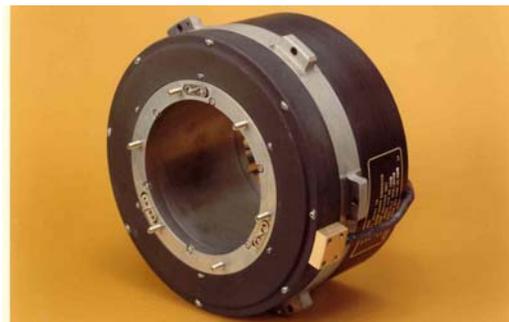
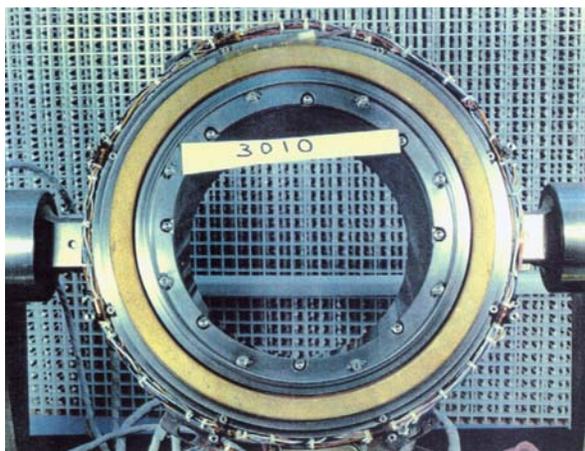
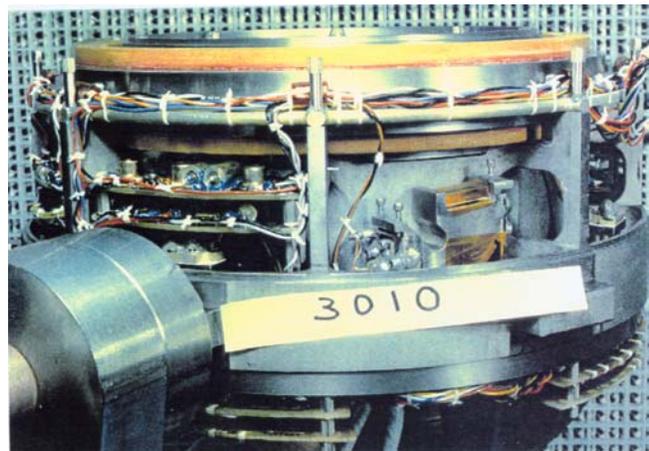
Figure 1. SSS Motor/Encoder assembly (Top). HST FGS-1 SSS-B after cover removal (Bottom) ^[3]

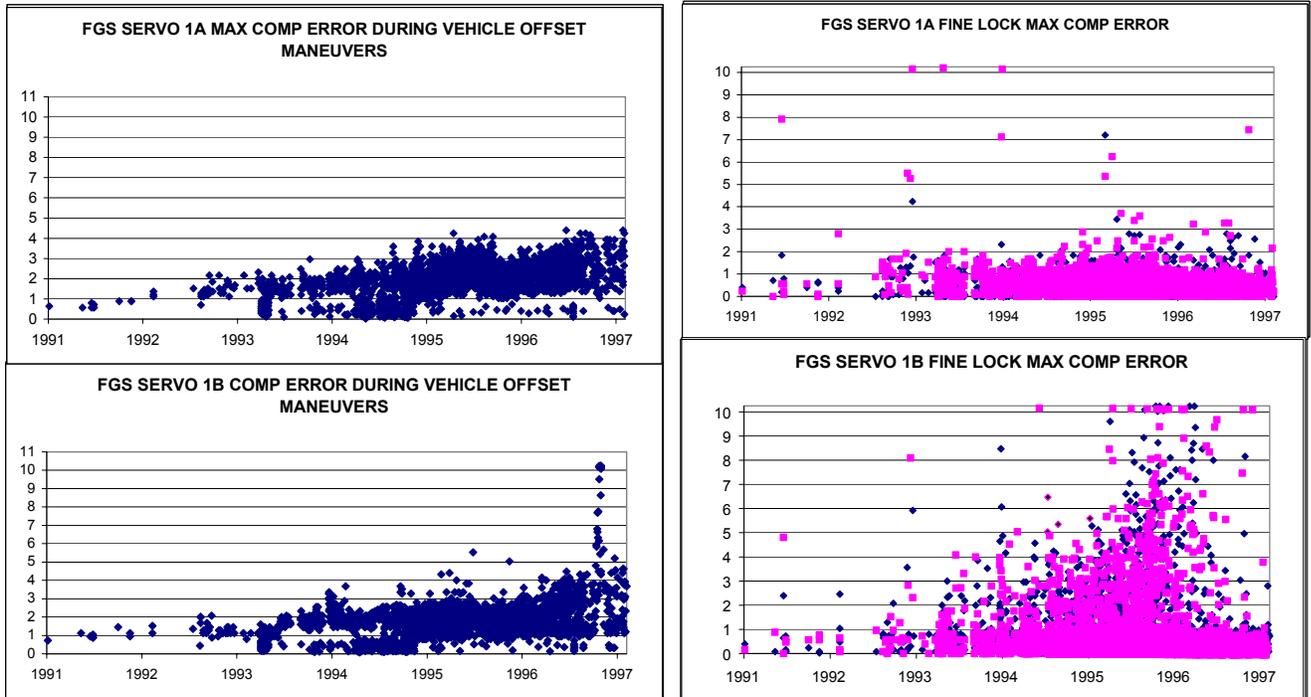
Figure 2. Max Compensated Error (CE) during vehicle offset maneuvers showing CT bumps (Left), and during Fine Lock showing Reversal Bumps (Right). Note: motor stall can occur above 10V Comp Error.

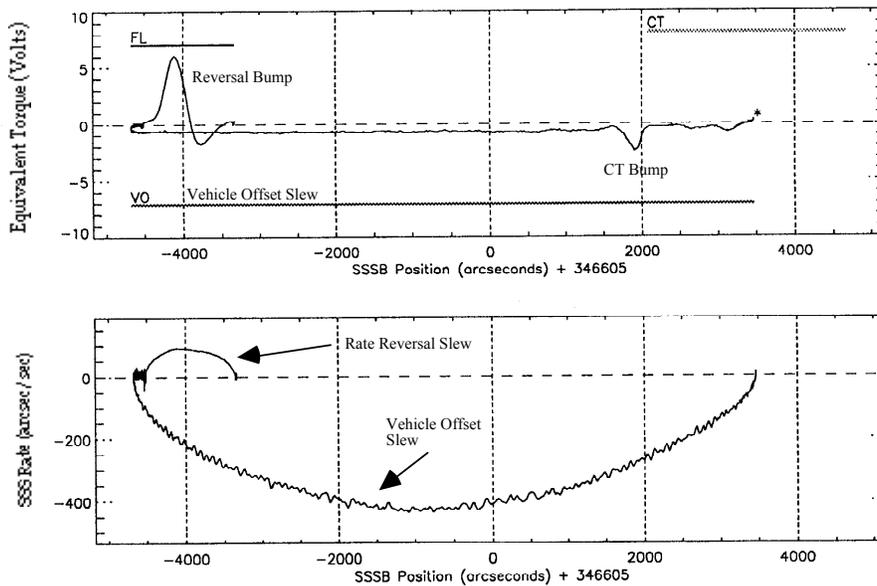
Figure 3. Example of FGS-1 SSS-B Reversal Bump. Initial direction of motion is right to left. Note CT bump at end of CT stroke (bar, upper panel). Direction reverses at a position of about -4,700 arcseconds and a 6.1-volt Reversal Bump forms. [2]

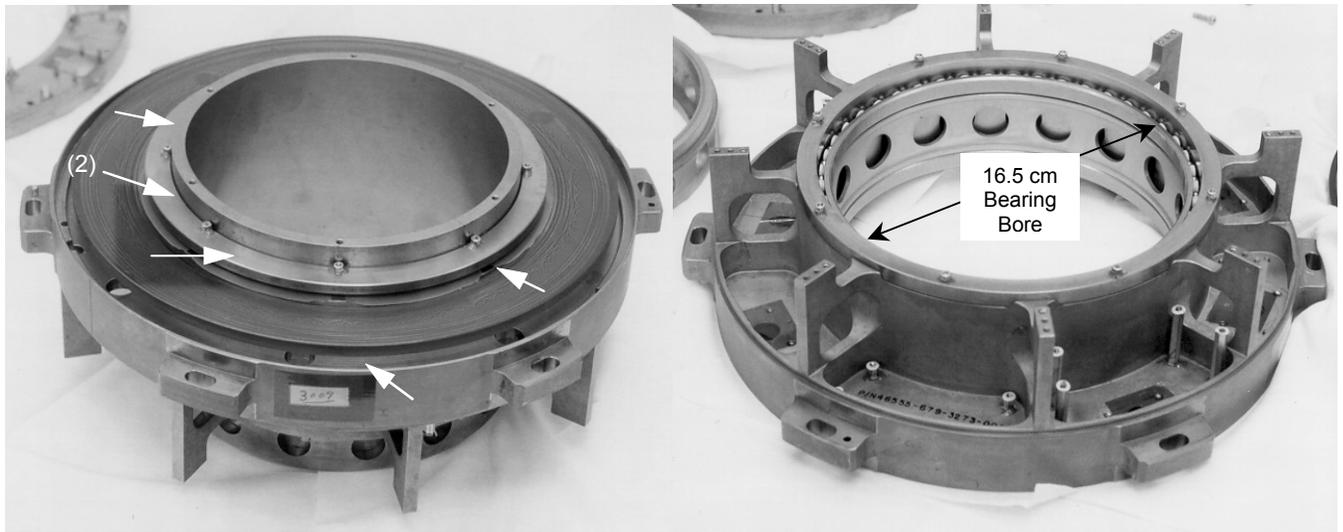
Figure 4. FGS-1 Motor/Encoder SSS-A bearing assy. Encoder optical disk shown (white particulate identified by white arrows) (Left). Clamp Ring removed and 0107B bearing exposed for inspection (Right).^[1]

A white-grainy material was observed on the shafts and clamp rings of both motor/encoders. The bearing clamp ring is machined beryllium S-200E, with no coating. The shaft material is also machined beryllium, but with an electroless Ni coating. After removing a small portion of the residue, the clamp rings were found to contain many small pits. Samples of the white residue were probed off both clamp rings, dissolved in 1% ultra pure nitric acid, and analyzed by ICP/MS (Inductively Coupled Plasma/Mass Spectrometry). High levels of beryllium were detected, however, due to the difficulty of isolating the white residues, only minute samples were tested thereby limiting the quantitative accuracy of the reported results.

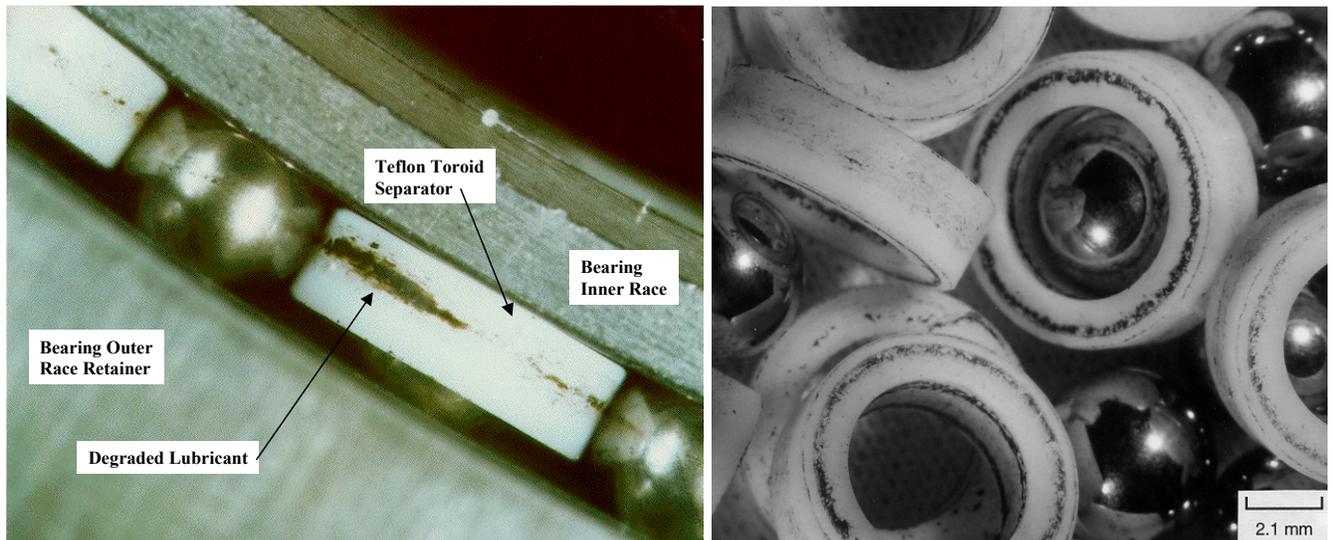
Both SSS-A and SSS-B bearings contained degraded lubricant residue, little to no free oil and were heavily contaminated with foreign fibers, metallic and non-metallic particles. None of the bearing components appeared to have experienced significant wear. With the exceptions that the lubricant in 0106 (SSS-B) bearings was slightly less degraded than the 0107 (SSS-A) bearings, and the 0107 bearings had less non-metallic particles (mostly skin), there was no other obvious differences between the relative condition of the bearings. The observed differences were insufficient to explain conclusively why the 0106 bearings in FGS-1B experienced reversal bumps and the A-servo did not. However, the

difference in location of the degraded lubricant on the toroid (faces of 0106 and bore / OD of 0107) with its observed motion during reversal provides a hypothesis of increased friction between the toroid and race land. The more degraded lubricant condition in the 0107 bearings is consistent with the observation that all of the A-side servos generally have more serious CT bump problems than the B-side servos. Figure 6 is photographs of the 0107 and 0106 bearings and lubricant degradation products.

Figure 6. Bearing 0107B (SSS-A) mounted in bearing assembly housing (Left). Bearing 0106A (SSS-B), balls and toroids after bearing disassembly (Right). Note locations of degraded lubricant on the separator. ^[1]

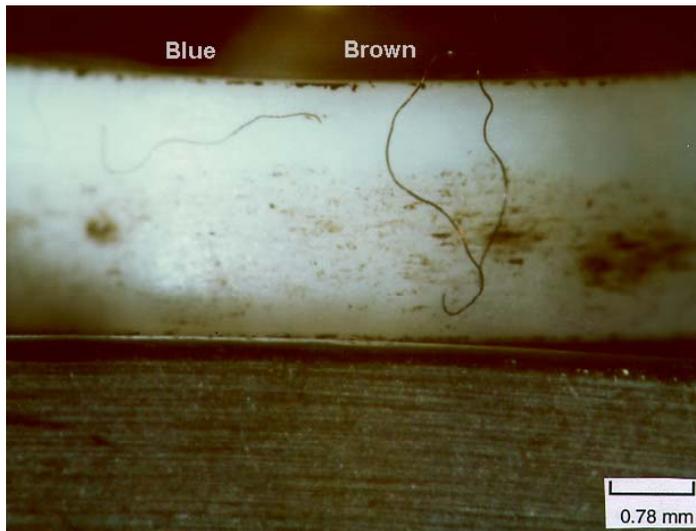
M/E 3010, Bearing 0106B, Blue (left) and brown (right) fibers found on toroid prior to flushing. FTIR indicated blue to be cellulosic, and brown to be polyamide.

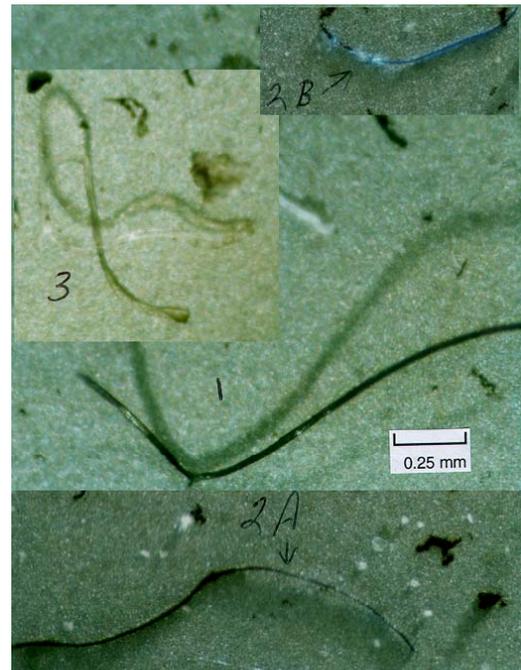
Figure 7 shows the fibers from the 0106B bearing. Table 2 lists the fiber size distributions from each of the four bearings. Most obvious from the table is that the 0106B bearing flush has a greater number of fibers in each size-range class. Also, there were more fibers observed in the "B" bearings than in the "A" bearings. The entire filter surface was scanned at 50x magnification. As shown, a large number of fibers (>60 on each filter) were counted in the bearing-flush debris. To characterize, 8 to 9 fibers of different types were selected for infrared analysis. The infrared spectra show that the fibers from each of the bearings are predominately polyester and cellulosic based compounds. Several polyamide-based fibers (nylon 6 or 66 in some cases) and an acrylic fiber were also observed. Figure 8 shows the associated FTIR analysis for a particular fiber from this bearing.

Figure 7. Bearing 0106B fibers removed from filter paper debris and analyzed by FTIR. [1]

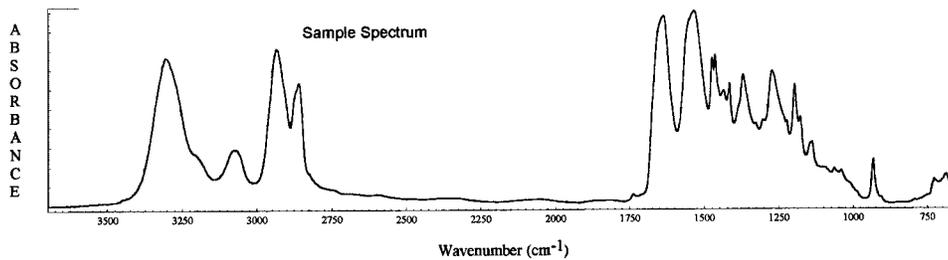
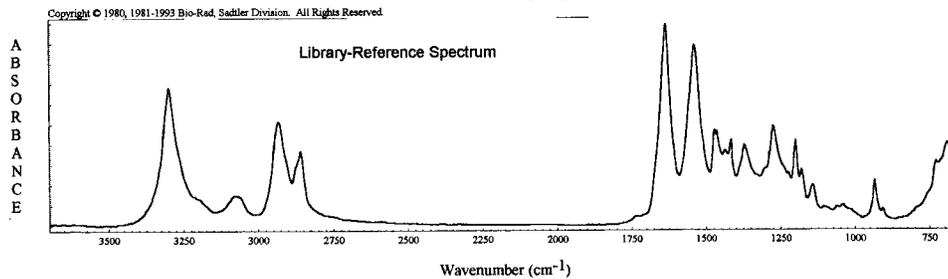
Figure 8. FTIR spectra of nylon library ref. (bottom) and fiber found in 0106B bearing (top). ^[1]

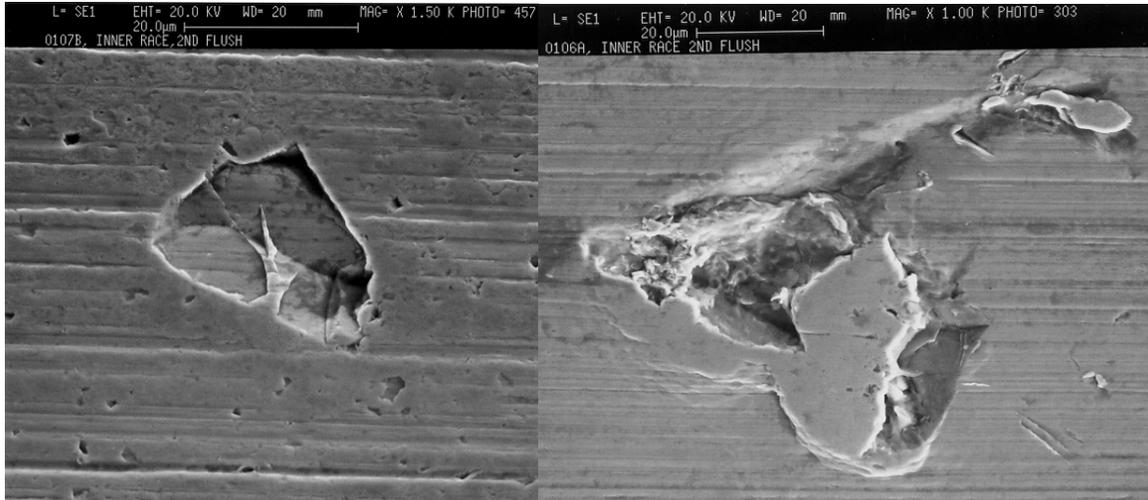
Four balls per bearing were examined using SEM. The damage on the balls was similar to those observed on the races, except smaller, typically less than 20 micrometers. Multi-fragment dents and pits/pullouts were noted in at least one of the four balls from each bearing. The most prevalent damage in the ball track of the inner races, as observed using SEM, was indents. The indents typically ranged in size from 20-100 micrometers in diameter, a few were less than 20 micrometers. Some bearing inner races had indent patterns that were repeated on the same race which suggested that debris was able to cling to a ball or toroid as it rolled on the race. The Fringe, defined as plastically deformed metal at the edge of a pit or indent that resulted from excavated or plowed material, may be capable of causing repeated bumping during service, hence, the damage was categorized as with or without fringe. Figure 9 illustrates two examples of a damage fringe. One that has been rolled over during service operation and one that has not.

Figure 9. SEM photomicrograph of bearing 0107B indent without plastic deformation or without edge fringe (Left) and SEM photomicrograph of bearing 0106A with multi-fragment indent with plastic deformation or fringe (Right). [1]

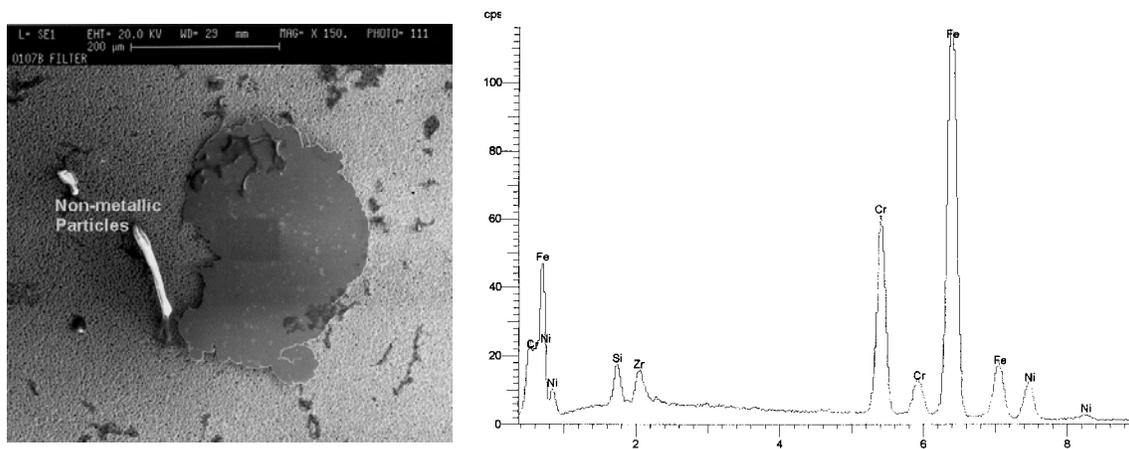
Figure 10. Bearing 0107B SEM of particle. [1]

Flushed particles that appeared metallic were also analyzed by SEM / EDS to determine their origin. Figure 10 is an example of a 300 series stainless steel particle with a smooth surface. These surface characteristics indicate that the particle was most likely in the bearing raceway at some point and rolled over by the balls during operation. The origin of this particle is probably from the mechanism fasteners.

Bearing 0107B, SEM micrograph (left) and corresponding EDS spectrum (right) of thick metallic particle, approximately 375 micrometers in length. EDS spectrum indicated Fe, Cr, Ni, and Zr, probably a 300-series stainless steel. Particle was thick enough to block filter paper Ag signal.
